**Flood Control Project Maintenance  
Levee Inspections**

**Fall 2011 Levee Maintenance Deficiency Summary Report**

**Reclamation District No. 1001 Nicolaus**

**Levee Inspection Report By Mile - Fall 2011**

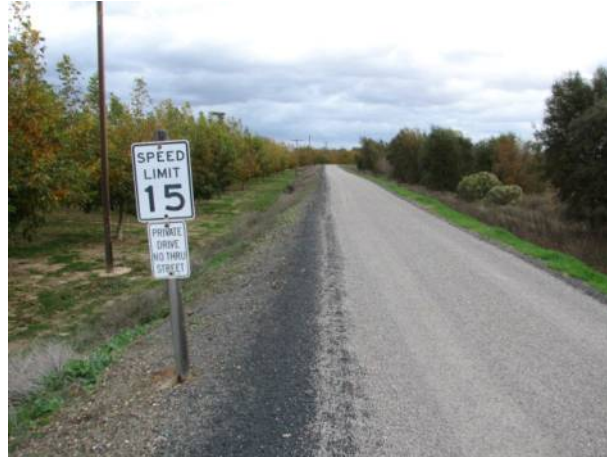
cathom\_f\_20111201\_008.jpg

Levee Mile Report Line	1
Start Levee Mile	0.47
End Levee Mile	4.15
Location	Land Side
Category	Earthen Levee
Item	Vegetation

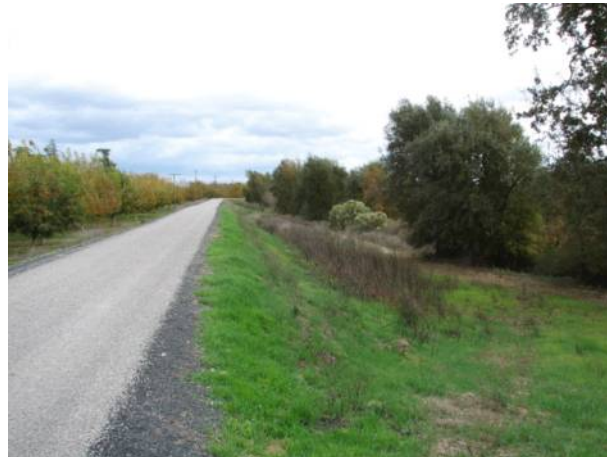
cathom\_f\_20111201\_007.jpg

Levee Mile Report Line	2
Start Levee Mile	0.47
End Levee Mile	4.15
Location	Water Side
Category	Earthen Levee
Item	Vegetation

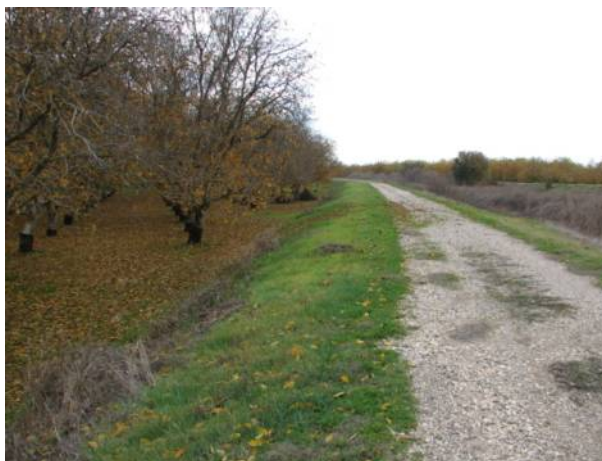
cathom\_f\_20111201\_010.jpg

Levee Mile Report Line	2
Start Levee Mile	0.04
End Levee Mile	3.63
Location	Land Side
Category	Earthen Levee
Item	Vegetation

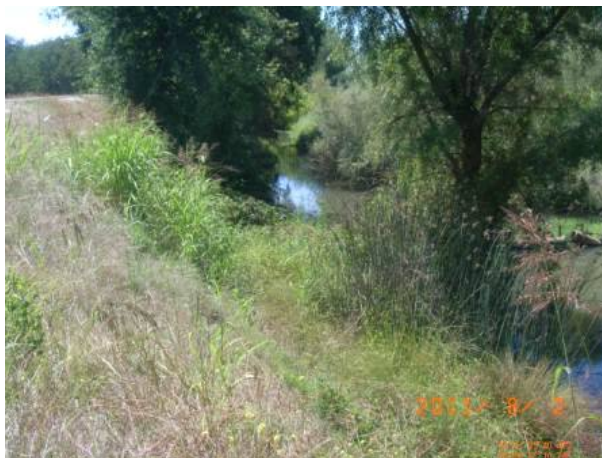
USACE2011\_YAS\_1-7\_L\_1.jpg

Levee Mile Report Line	11
Start Levee Mile	1.28
End Levee Mile	1.29
Location	Water Side
Category	Supplemental
Item	USACE Erosion Survey

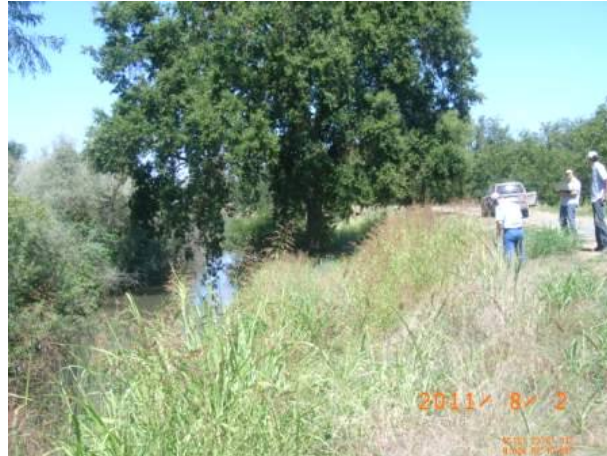
Levee Mile Report Line	11
Start Levee Mile	1.28
End Levee Mile	1.29
Location	Water Side
Category	Supplemental
Item	USACE Erosion Survey
USACE 2011 Photo #2	
USACE2011_YAS_1-7_L_2.jpg

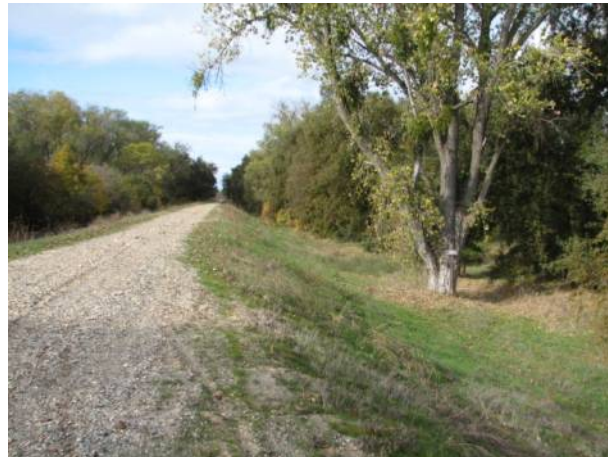
cathom\_f\_20111201\_006.jpg

Levee Mile Report Line	2
Start Levee Mile	0.01
End Levee Mile	10.68
Location	Water Side
Category	Earthen Levee
Item	Vegetation

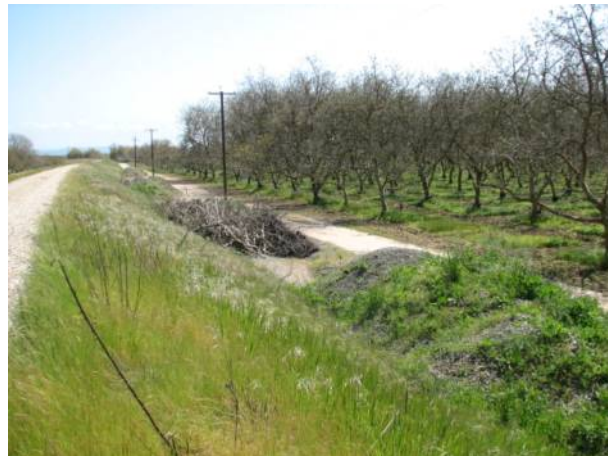
cathom\_f\_20110929\_633.jpg

Levee Mile Report Line	8
Start Levee Mile	3.80
End Levee Mile	3.96
Location	Land Side
Category	Earthen Levee
Item	Encroachments

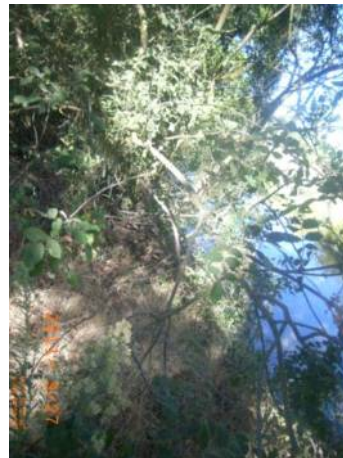
USACE2011\_BER\_5-7\_L\_2.jpg

LMR No.	Levee Mile		Category	Item	Location *	Rating **	Action/Comment	GPS Latitude/Longitude		Issue No.
	Start	End						Start	End	Photo
20	7.16	7.29	Supplemental	USACE Erosion Survey	WS	M	Inspector Comments: 2008 - Sandy/silty banks with rotational slab failures creating near vertical bank with pop-outs due to tree failures. Narrow berm. 2011: No observed change. [2011 Site ID: BER_5-7_L]	38.982737 ° -121.501144 °	38.982572 ° -121.502797 °	11 Y
21	10.01	10.01	Earthen Levee	Encroachments	CR	C	Equipment Inspector Comments: Levee blocked for new bridge construction.	38.969410 ° -121.542127 °	38.969410 ° -121.542127 °	35
22	10.37	10.41	Supplemental	USACE Erosion Survey	WS	M	Inspector Comments: 2011: A large section of bank has slumped off, RD has flagging up, appears to be watching. [2011 Site ID: BER_2-5_L]	38.964583 ° -121.544967 °	38.964010 ° -121.545228 °	19 Y
23	11.05	11.21	Supplemental	USACE Erosion Survey	WS	M	Inspector Comments: 2011: Large slumped sections of bank. [2011 Site ID: BER_1-9_L]	38.955070 ° -121.549528 °	38.954227 ° -121.550592 °	20 Y

Levee Mile Report Line	20
Start Levee Mile	7.16
End Levee Mile	7.29
Location	Water Side
Category	Supplemental
Item	USACE Erosion Survey

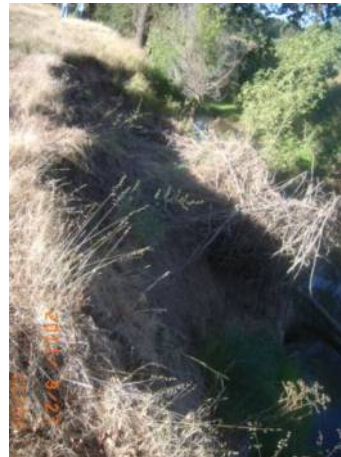
USACE2011\_BER\_2-5\_L\_2.jpg

Levee Mile Report Line	22
Start Levee Mile	10.37
End Levee Mile	10.41
Location	Water Side
Category	Supplemental
Item	USACE Erosion Survey

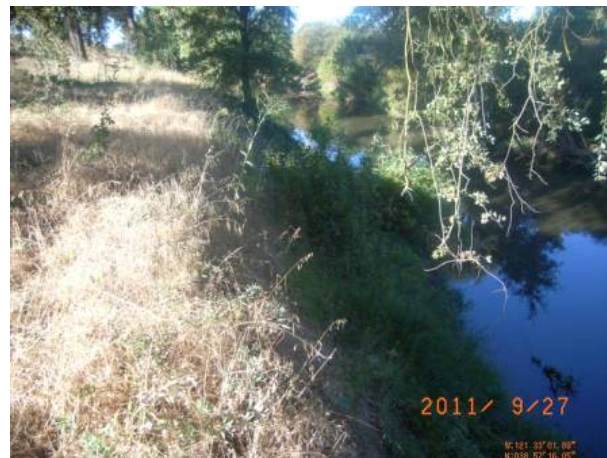
USACE2011\_BER\_1-9\_L\_1.jpg

Levee Mile Report Line	23
Start Levee Mile	11.05
End Levee Mile	11.21
Location	Water Side
Category	Supplemental
Item	USACE Erosion Survey

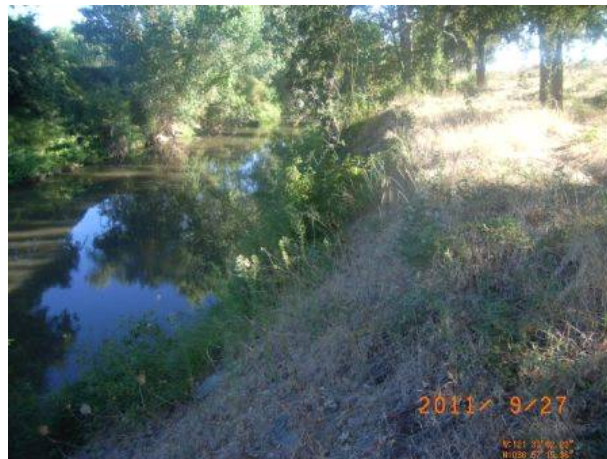
USACE2011\_BER\_1-9\_L\_3.jpg

Levee Mile Report Line	23
Start Levee Mile	11.05
End Levee Mile	11.21
Location	Water Side
Category	Supplemental
Item	USACE Erosion Survey

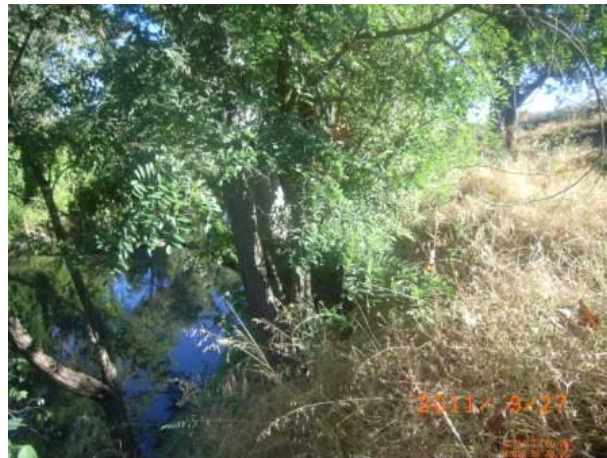
USACE2011\_BER\_0-8\_L\_1.jpg

24	11.29	11.32	Earthen Levee	Vegetation	LS	M	Elderberries are blocking visibility and flood fight capability.	38.953367 ° -121.551428 °	38.953025 ° -121.551808 °	22
25	12.07	12.07	Supplemental	USACE Erosion Survey	WS	M	Inspector Comments: 2006 - Multiple rotational failures in the berm. Erosion is into the levee toe and lower slope. Tension cracks extensive at top of bank. Cohesive toe creates a bench on which failures occur. 2007 - Still steep bank with some berm with pistol-butted reeds. 2011: No observed change. [2011 Site ID: BER_0-8_L]	38.946477 ° -121.564094 °	38.947297 ° -121.563565 °	21 Y
26	12.24	12.24	Earthen Levee	Vegetation	LS	M	Elderberries are blocking visibility and flood fight capability.	38.946248 ° -121.564220 °	38.946248 ° -121.564220 °	27

Levee Mile Report Line	25
Start Levee Mile	12.07
End Levee Mile	12.07
Location	Water Side
Category	Supplemental
Item	USACE Erosion Survey

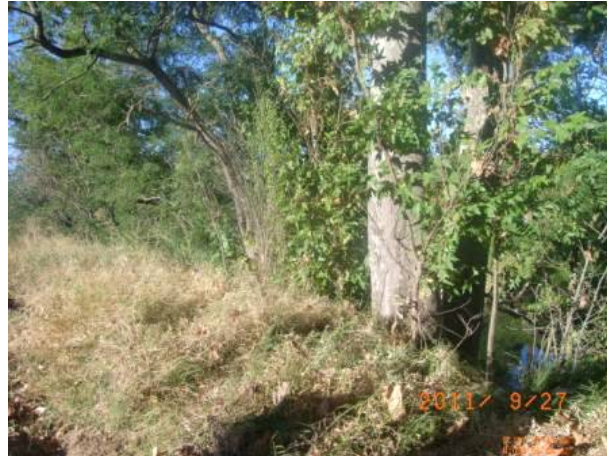
Levee Mile Report Line	25
Start Levee Mile	12.07
End Levee Mile	12.07
Location	Water Side
Category	Supplemental
Item	USACE Erosion Survey
USACE 2011 Photo #2	
USACE2011_BER_0-8_L_2.jpg

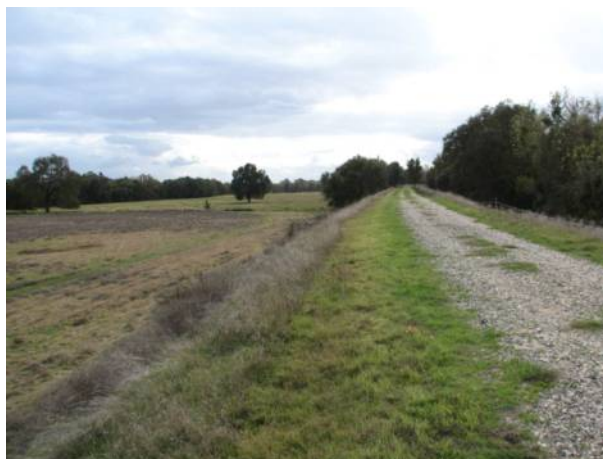
cathom\_f\_20111201\_011.jpg

Levee Mile Report Line	2
Start Levee Mile	0.03
End Levee Mile	2.00
Location	Land Side
Category	Earthen Levee
Item	Vegetation

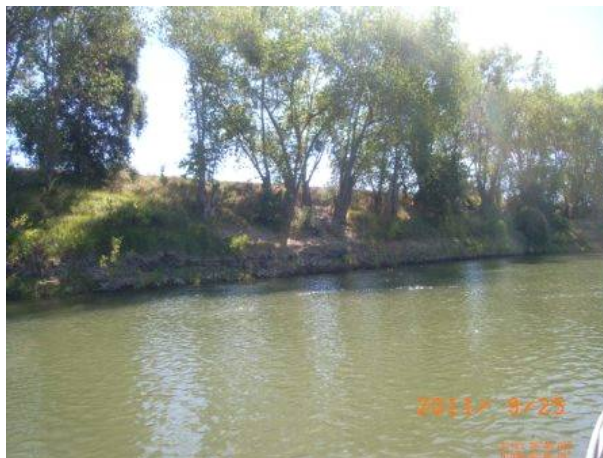
USACE2011\_FHR\_7-0\_L\_1.jpg

6	3.22	3.22	Earthen Levee	Encroachments	LS	PO	Landscaping	38.899732 ° -121.584110 °	38.899732 ° -121.584110 °	31
7	5.21	13.31	Earthen Levee	Vegetation	WS	A	Remove the wild growth other than native grasses from the levee slopes.	38.882620 ° -121.611272 °	38.781319 ° -121.606207 °	2
8	5.21	13.31	Earthen Levee	Vegetation	LS	A	Remove the wild growth other than native grasses from the levee slopes.	38.882619 ° -121.611271 °	38.781319 ° -121.606208 °	1
9	5.27	5.36	Supplemental Survey	USACE Erosion Survey	WS	M	Inspector Comments: 2000 - Some active toe erosion of a damaged old cobble site. 2005 - Small amount of additional erosion at the waterline. 2008 - Plans for repair currently in the design phase. 2010 - Old deteriorating cobble site. Fresh fallen tree. 2011: This site is currently under contract for repair. Repairs should be complete in 2012. [2011 Site ID: FHR_7-0_L]	38.879779 ° -121.612228 °	38.878713 ° -121.612728 °	4 Y

Levee Mile Report Line	9
Start Levee Mile	5.27
End Levee Mile	5.36
Location	Water Side
Category	Supplemental
Item	USACE Erosion Survey

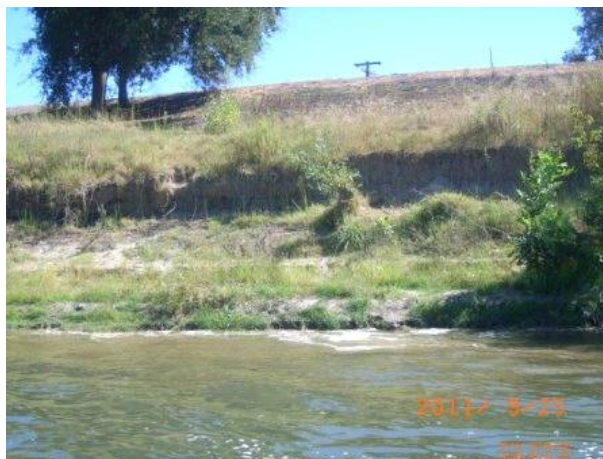
USACE2011\_FHR\_6-6\_L\_1.jpg

Levee Mile Report Line	10
Start Levee Mile	5.78
End Levee Mile	5.86
Location	Water Side
Category	Supplemental
Item	USACE Erosion Survey

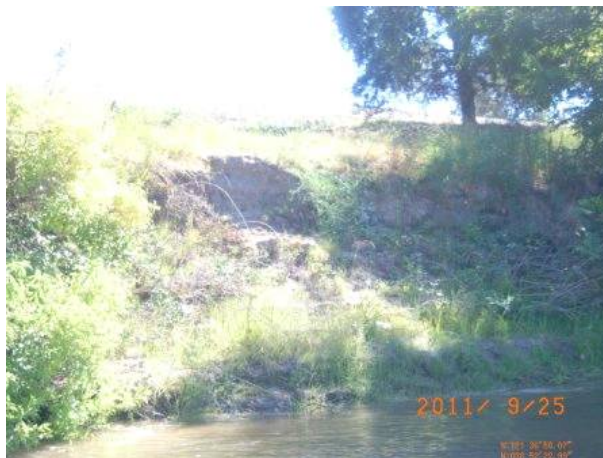
USACE2011\_FHR\_6-6\_L\_2.jpg

Levee Mile Report Line	10
Start Levee Mile	5.78
End Levee Mile	5.86
Location	Water Side
Category	Supplemental
Item	USACE Erosion Survey

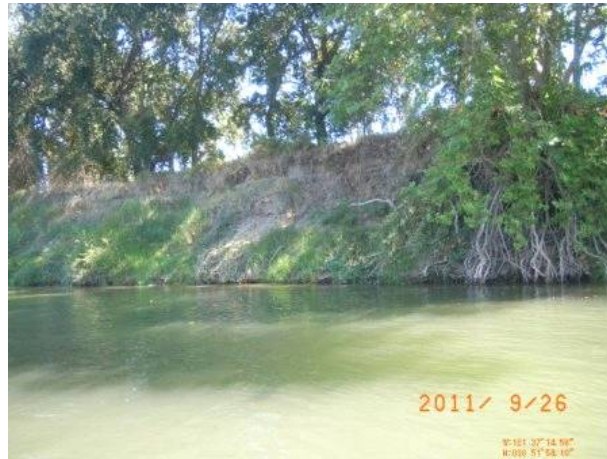
USACE2011\_FHR\_6-0\_L\_1.jpg

Levee Mile Report Line	11
Start Levee Mile	6.38
End Levee Mile	6.45
Location	Water Side
Category	Supplemental
Item	USACE Erosion Survey

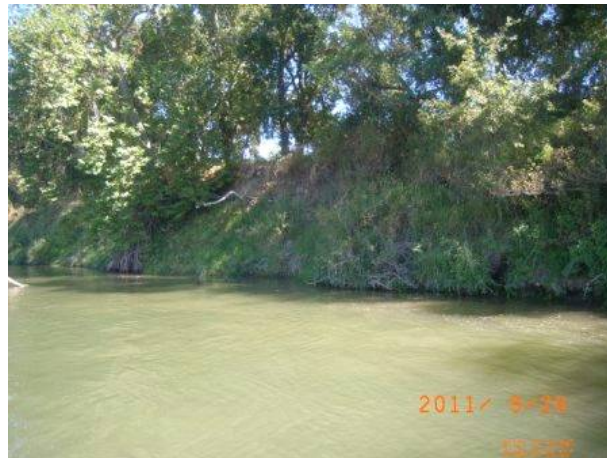
USACE2011\_FHR\_6-0\_L\_2.jpg

Levee Mile Report Line	11
Start Levee Mile	6.38
End Levee Mile	6.45
Location	Water Side
Category	Supplemental
Item	USACE Erosion Survey

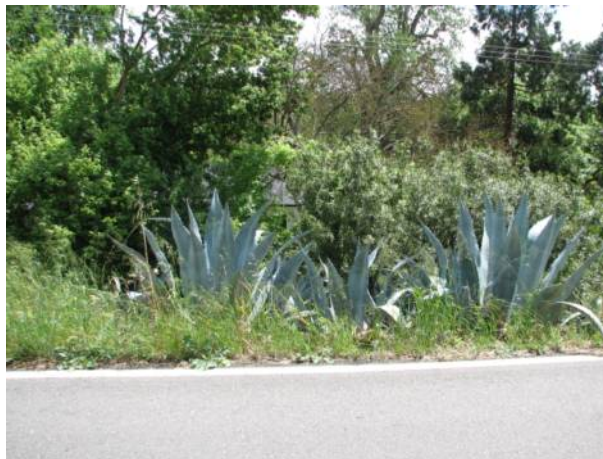
cathom\_f\_20110929\_639.jpg

Levee Mile Report Line	12
Start Levee Mile	6.48
End Levee Mile	6.48
Location	Land Side
Category	Earthen Levee
Item	Encroachments

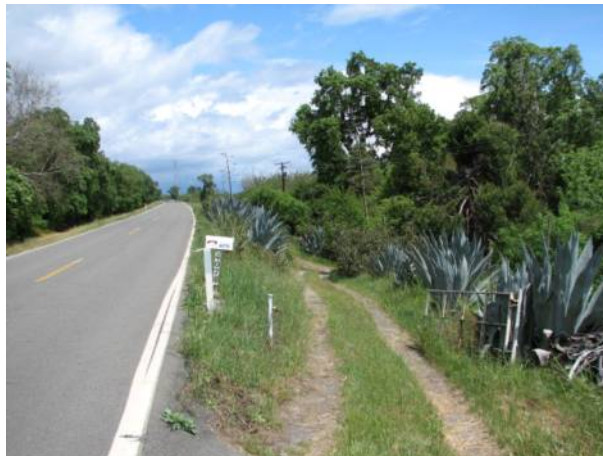
cathom\_f\_20110929\_640.jpg

Levee Mile Report Line	12
Start Levee Mile	6.48
End Levee Mile	6.48
Location	Land Side
Category	Earthen Levee
Item	Encroachments

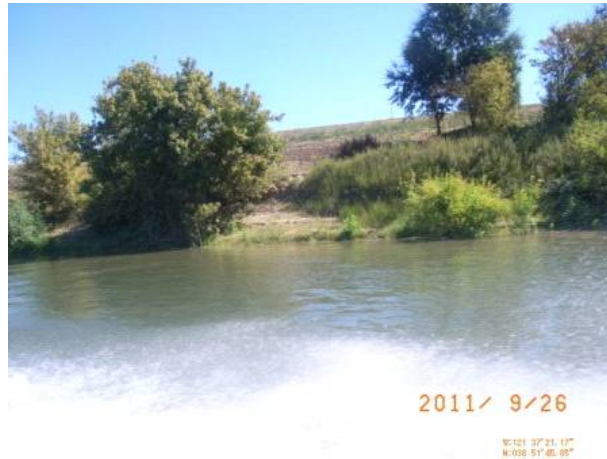
USACE2011\_FHR\_5-8\_L\_2.jpg

Levee Mile Report Line	13
Start Levee Mile	6.63
End Levee Mile	6.72
Location	Water Side
Category	Supplemental
Item	USACE Erosion Survey

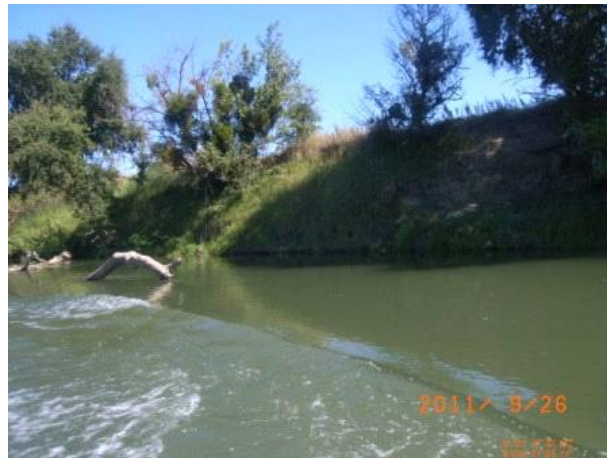
USACE2011\_FHR\_5-0\_L\_1.jpg

Levee Mile Report Line	16
Start Levee Mile	7.56
End Levee Mile	7.73
Location	Water Side
Category	Supplemental
Item	USACE Erosion Survey

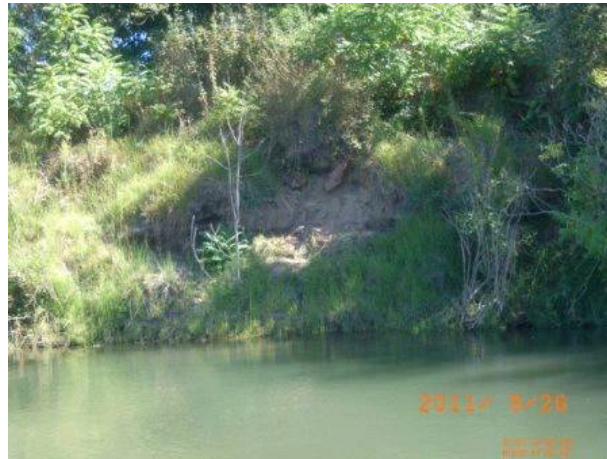
USACE2011\_FHR\_5-0\_L\_3.jpg

Levee Mile Report Line	16
Start Levee Mile	7.56
End Levee Mile	7.73
Location	Water Side
Category	Supplemental
Item	USACE Erosion Survey

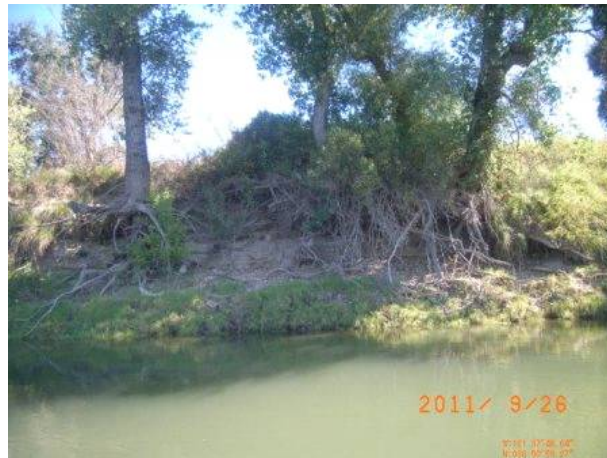
USACE2011\_FHR\_5-0\_L\_4.jpg

Levee Mile Report Line	16
Start Levee Mile	7.56
End Levee Mile	7.73
Location	Water Side
Category	Supplemental
Item	USACE Erosion Survey

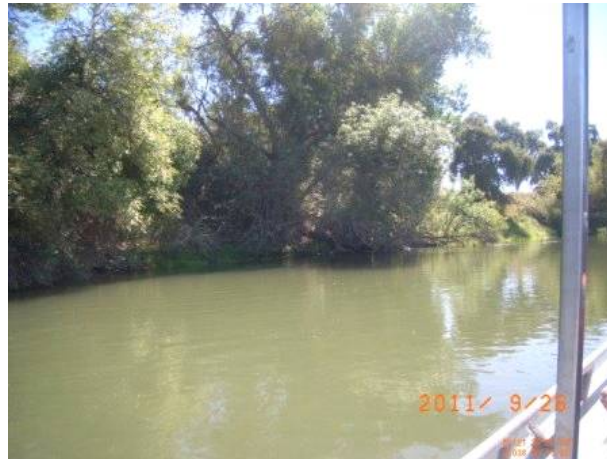
USACE2011\_FHR\_3-8\_L\_1.jpg

Levee Mile Report Line	17
Start Levee Mile	8.53
End Levee Mile	8.95
Location	Water Side
Category	Supplemental
Item	USACE Erosion Survey

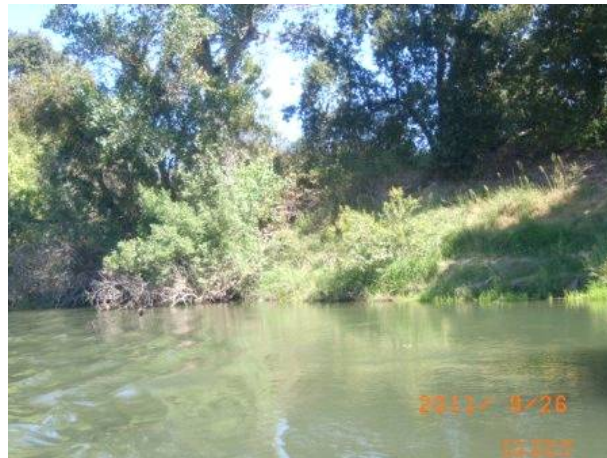
USACE2011\_FHR\_3-8\_L\_2.jpg

Levee Mile Report Line	17
Start Levee Mile	8.53
End Levee Mile	8.95
Location	Water Side
Category	Supplemental
Item	USACE Erosion Survey

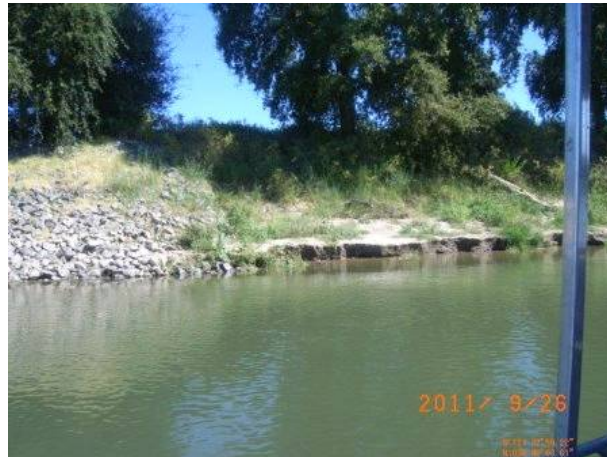
USACE2011\_FHR\_1-0\_L\_1.jpg

Levee Mile Report Line	21
Start Levee Mile	11.19
End Levee Mile	11.44
Location	Water Side
Category	Supplemental
Item	USACE Erosion Survey

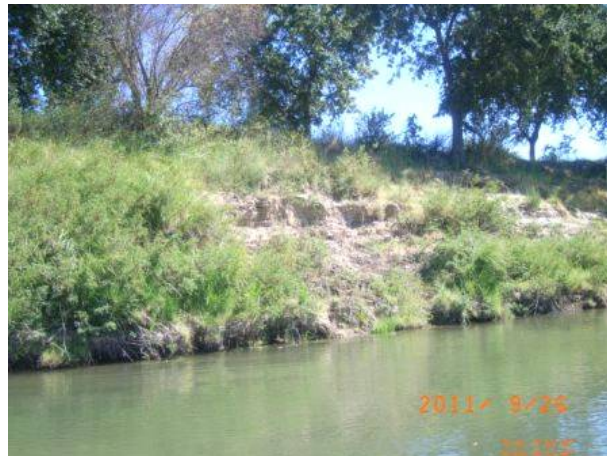
USACE2011\_FHR\_1-0\_L\_2.jpg

Levee Mile Report Line	21
Start Levee Mile	11.19
End Levee Mile	11.44
Location	Water Side
Category	Supplemental
Item	USACE Erosion Survey

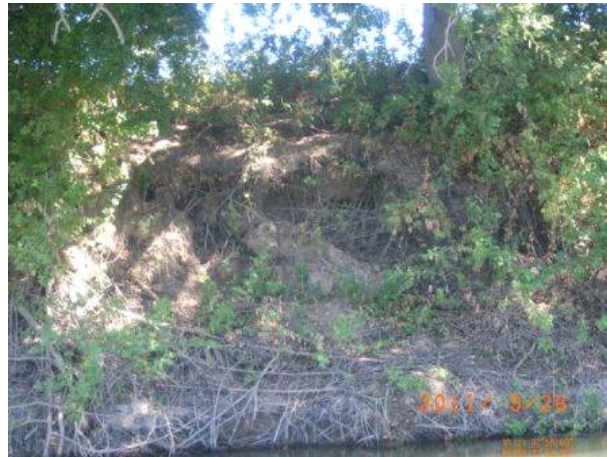
USACE2011\_FHR\_1-0\_L\_4.jpg

Levee Mile Report Line	21
Start Levee Mile	11.19
End Levee Mile	11.44
Location	Water Side
Category	Supplemental
Item	USACE Erosion Survey

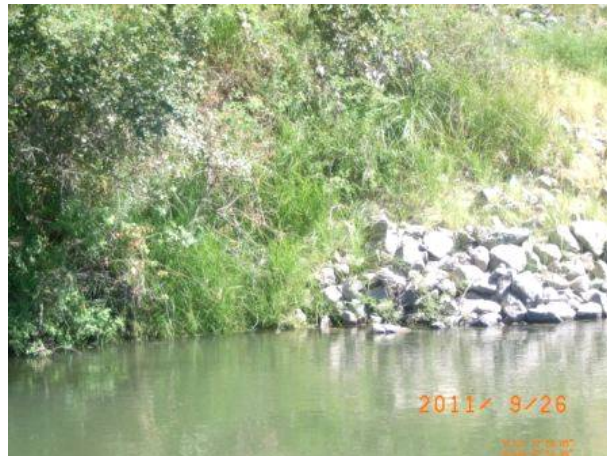
USACE2011\_FHR\_1-0\_L\_5.jpg

Levee Mile Report Line	21
Start Levee Mile	11.19
End Levee Mile	11.44
Location	Water Side
Category	Supplemental
Item	USACE Erosion Survey

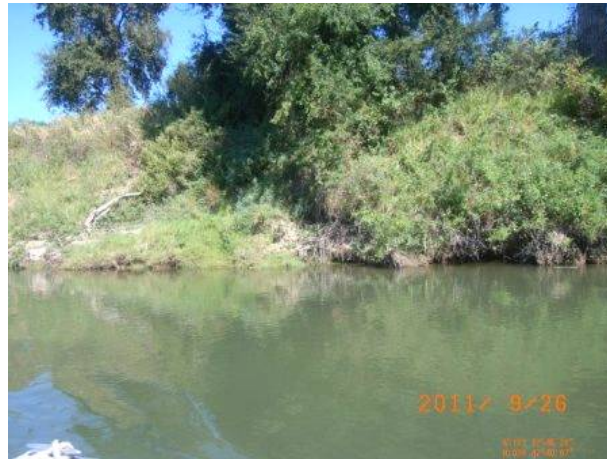
USACE2011\_FHR\_0-6\_L\_2.jpg

23	11.58	11.76	Supplemental	USACE Erosion Survey	WS	M	Inspector Comments: 1997- Deposits over top of cobble on the upper slope. 2000 - Old cobble site in poor shape; some toe retreat, but little change; steep bank. 2010 - Site extended upstream due to new toe erosion. 2011: No observed change. [2011 Site ID: FHR_0-6_L]	38.795455 ° -121.629903 °	38.793394 ° -121.628156 °	27 Y
24	12.40	12.40	Earthen Levee	Vegetation	LS	M	Elderberries are blocking visibility and flood fight capability.	38.787355 ° -121.621165 °	38.787355 ° -121.621165 °	24
25	12.57	12.57	Earthen Levee	Encroachments	LS	CO	Buildings	38.786073 ° -121.618522 °	38.786073 ° -121.618522 °	25

Levee Mile Report Line	23
Start Levee Mile	11.58
End Levee Mile	11.76
Location	Water Side
Category	Supplemental
Item	USACE Erosion Survey

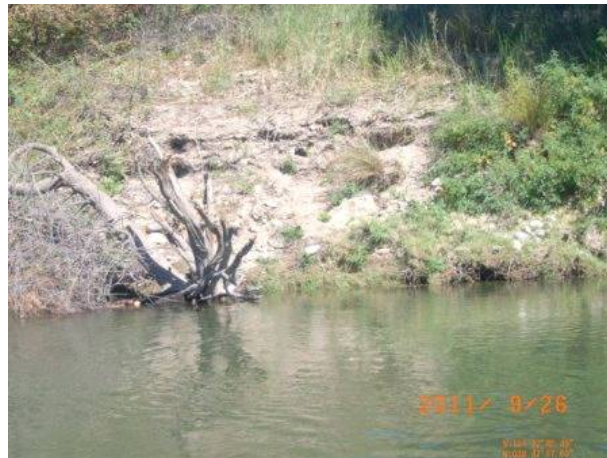
USACE2011\_FHR\_0-6\_L\_3.jpg

Levee Mile Report Line	23
Start Levee Mile	11.58
End Levee Mile	11.76
Location	Water Side
Category	Supplemental
Item	USACE Erosion Survey

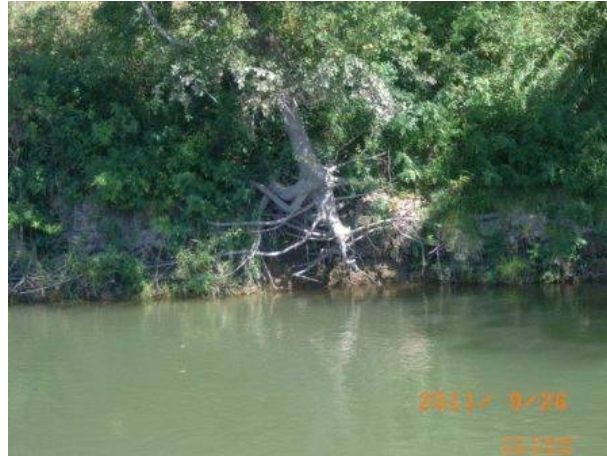
Levee Mile Report Line	23
Start Levee Mile	11.58
End Levee Mile	11.76
Location	Water Side
Category	Supplemental
Item	USACE Erosion Survey
USACE 2011 Photo #4	
USACE2011_FHR_0-6_L_4.jpg

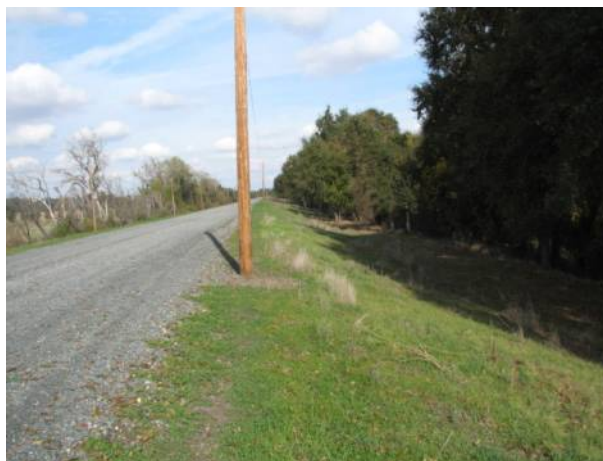
cathom\_f\_20111201\_013.jpg

Levee Mile Report Line	2
Start Levee Mile	0.14
End Levee Mile	5.39
Location	Water Side
Category	Earthen Levee
Item	Vegetation

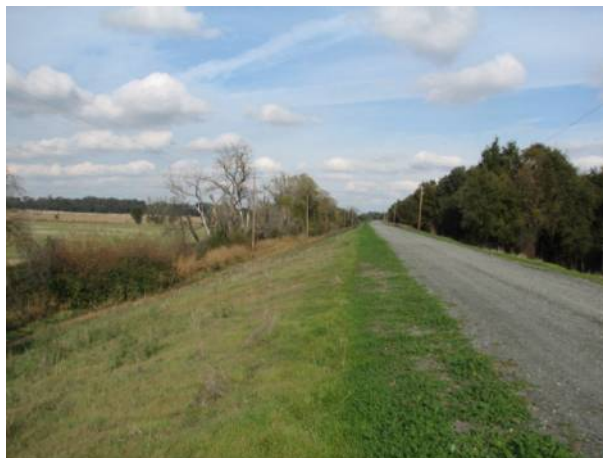
cathom\_f\_20111201\_014.jpg

Levee Mile Report Line	3
Start Levee Mile	0.14
End Levee Mile	5.39
Location	Land Side
Category	Earthen Levee
Item	Vegetation

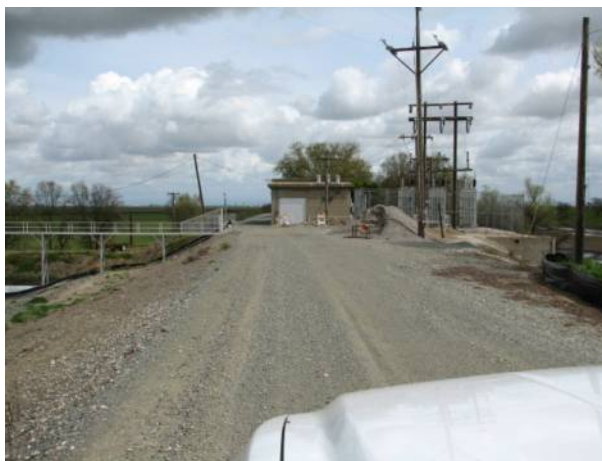
cathom\_f\_20110929\_642.jpg

Levee Mile Report Line	5
Start Levee Mile	0.83
End Levee Mile	0.83
Location	Water Side
Category	Earthen Levee
Item	Encroachments

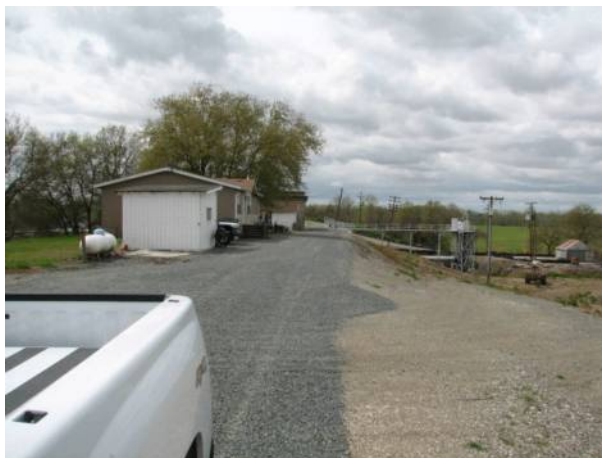
cathom\_f\_20110929\_643.jpg

Levee Mile Report Line	5
Start Levee Mile	0.83
End Levee Mile	0.83
Location	Water Side
Category	Earthen Levee
Item	Encroachments

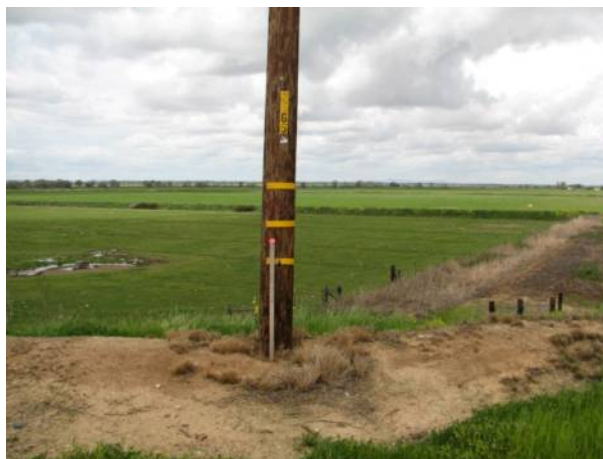
cathom\_f\_20110929\_646.jpg

6	1.15	1.15	Earthen Levee	Encroachments	LS	PO	Poles	38.793613 ° -121.592230 °	38.793613 ° -121.592230 °	6 Y
7	1.52	1.59	Earthen Levee	Slope Stability	LS	C	Repair slope instability.	38.796843 ° -121.586875 °	38.797417 ° -121.585949 °	13
8	2.24	2.24	Supplemental	USACE Erosion Survey	WS	M	Inspector Comments: 2006 - Noted old saturation slumping of upper levee slope that is into the levee core (near high water line). 2011: Erosion is into the top of the levee. This site is actually located at LM 2.5. [2011 Site ID: NCC_3-0_R]	38.803877 ° -121.575053 °	38.804206 ° -121.574529 °	15 Y
9	3.59	3.85	Earthen Levee	Encroachments	LS	PO	Poles	38.814919 ° -121.556712 °	38.817178 ° -121.552965 °	7 Y
10	3.69	3.69	Earthen Levee	Encroachments	WS	W	Equipment	38.815737 ° -121.555338 °	38.815737 ° -121.555338 °	8 Y
11	3.73	3.73	Earthen Levee	Encroachments	WS	W	Equipment	38.816155 ° -121.554650 °	38.816155 ° -121.554650 °	9

Levee Mile Report Line	6
Start Levee Mile	1.15
End Levee Mile	1.15
Location	Land Side
Category	Earthen Levee
Item	Encroachments

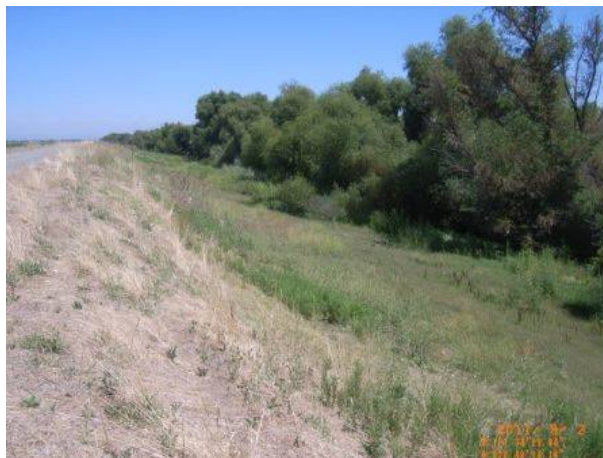
USACE2011\_NCC\_3-0\_R\_1.jpg

Levee Mile Report Line	8
Start Levee Mile	2.24
End Levee Mile	2.24
Location	Water Side
Category	Supplemental
Item	USACE Erosion Survey

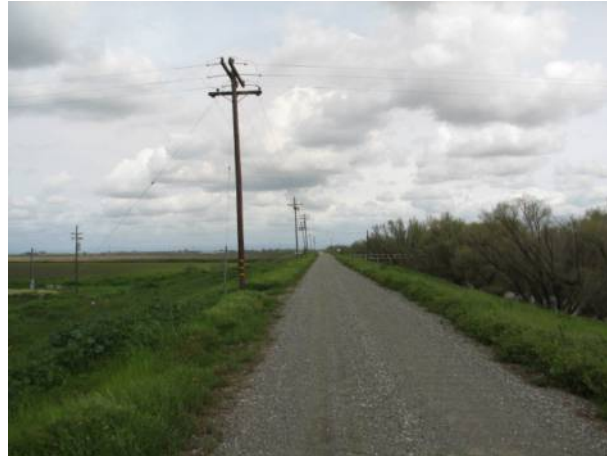
Levee Mile Report Line	9
Start Levee Mile	3.59
End Levee Mile	3.85
Location	Land Side
Category	Earthen Levee
Item	Encroachments
Poles on the land side shoulder levee mile 3.59 - 3.85.	
cathom_f_20110929_647.jpg

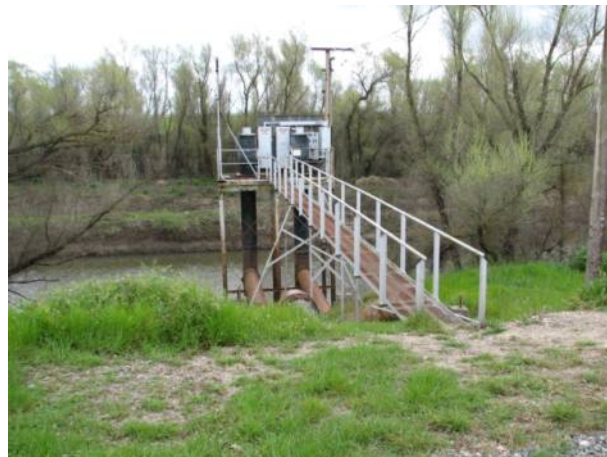
Levee Mile Report Line	10
Start Levee Mile	3.69
End Levee Mile	3.69
Location	Water Side
Category	Earthen Levee
Item	Encroachments
Pump water side levee mile 3.69.	
cathom_f_20110929_648.jpg

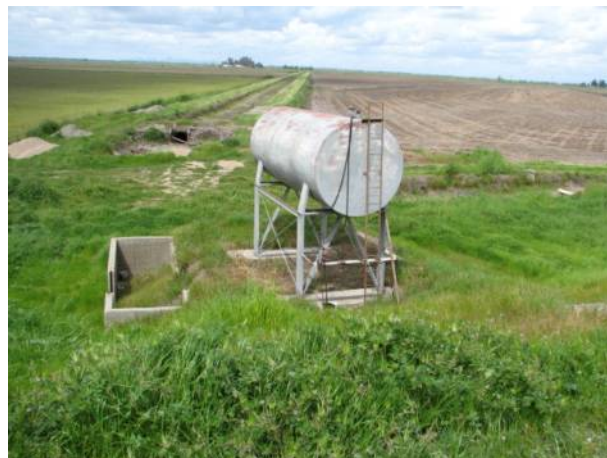
Levee Mile Report Line	13
Start Levee Mile	3.85
End Levee Mile	3.85
Location	Land Side
Category	Earthen Levee
Item	Encroachments
Storage tank on land side slope levee mile 3.85.	
cathom_f_20110929_649.jpg

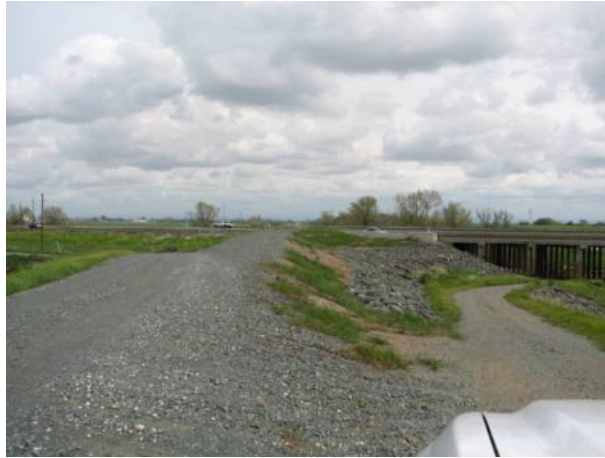
Levee Mile Report Line	14
Start Levee Mile	4.44
End Levee Mile	4.44
Location	Crown
Category	Earthen Levee
Item	Encroachments
Levee stops at hwy 70 and starts again on the other side of hwy 70.	
cathom_f_20110929_650.jpg

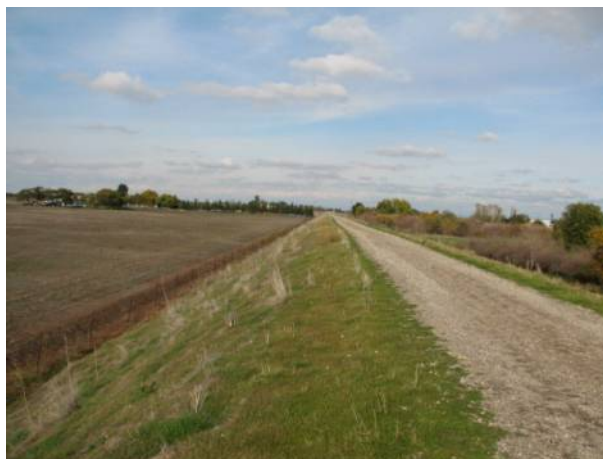
cathom\_f\_20111201\_016.jpg

Levee Mile Report Line	2
Start Levee Mile	0.02
End Levee Mile	4.71
Location	Land Side
Category	Earthen Levee
Item	Vegetation

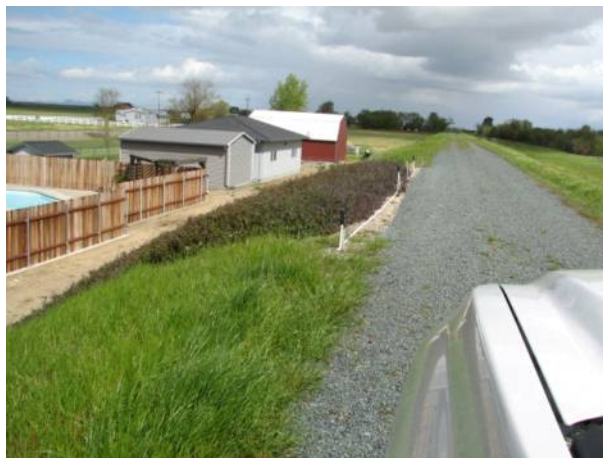
cathom\_f\_20110929\_653.jpg

Levee Mile Report Line	3
Start Levee Mile	1.06
End Levee Mile	1.06
Location	Land Side
Category	Earthen Levee
Item	Encroachments

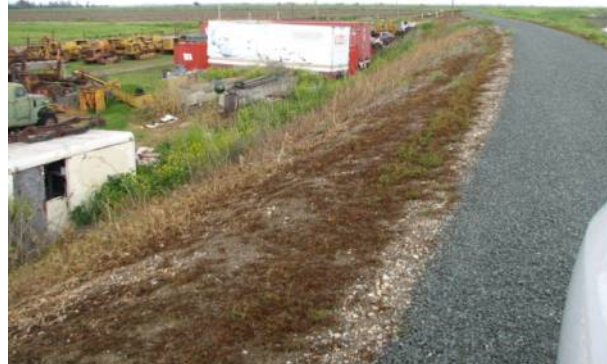
Levee Mile Report Line	5
Start Levee Mile	1.45
End Levee Mile	1.45
Location	Land Side
Category	Earthen Levee
Item	Encroachments
